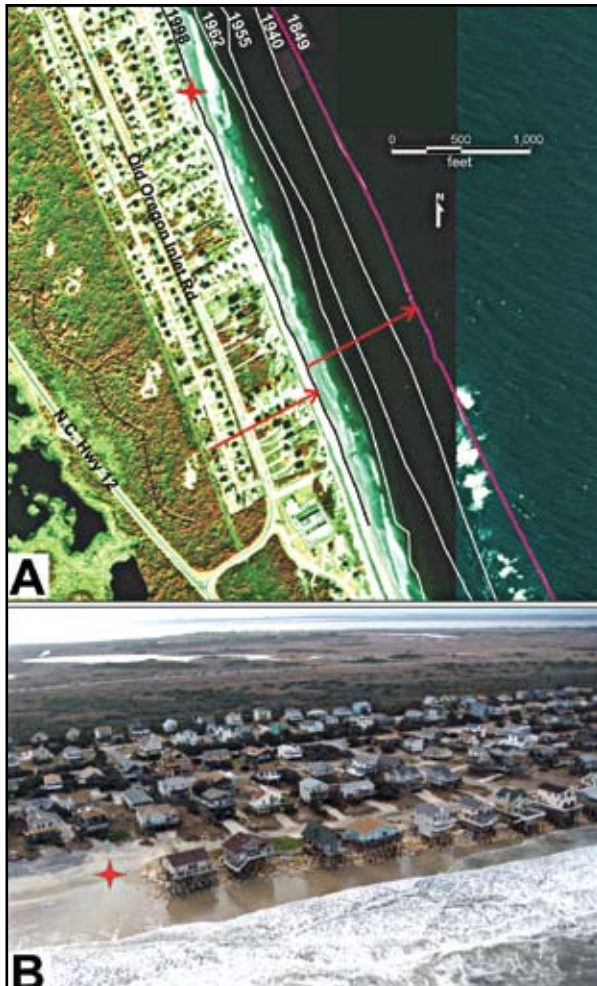
FIGURE 11. Panel A is a 1998 aerial photograph of a portion of South Nags Head on Bodie Island and displays the location of the 1849 shoreline (red line) relative to the shoreline location in 1998 (black line). The location of the shoreline is shown in a recessional sequence for 1940, 1955, and 1962 (white lines). Panel B is an oblique aerial photograph (2008) that shows a housing development built in the 1980s, encased in sand-bags for several decades, and the receding shoreline adjacent to the houses. The red star is the same location on both panels. Panel B photograph is by S. Riggs.

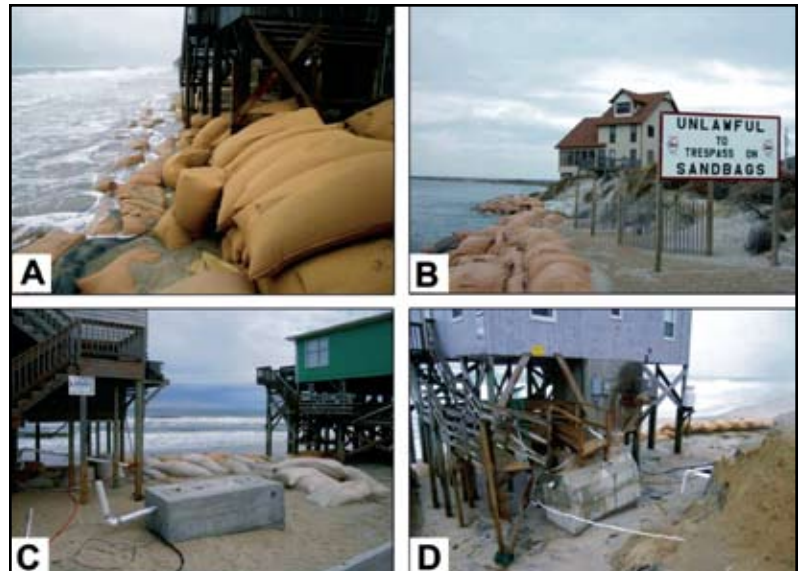
FIGURE 12. Photographs of sand-bagged houses in South Nags Head on Bodie Island (Panel A) and Bogue Inlet on Bogue Banks (Panel B) demonstrate the loss of the public beach. Photographs of sand-bagged houses in South Nags Head on Bodie Island (Panels C and D) with exposed and broken septic tanks and drain-fields. After storms these houses are condemned until the septic systems can be temporarily repaired and reburied in sand. Photographs are by S. Riggs.
